A Report on the Preservation of

# **BUDDHIST MONUMENTS**

At Bamiyan in Afghanistan

By: Dr. B.B.Lal and R.Sengupta

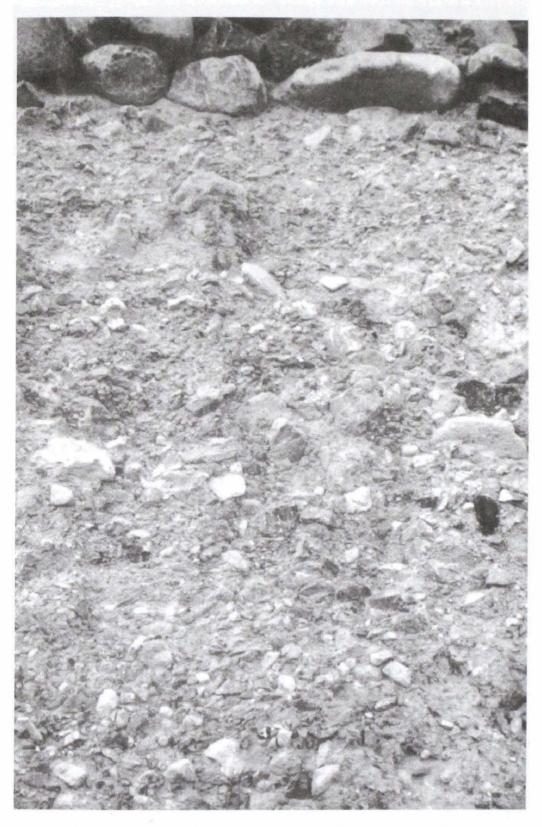
5. Section of the conglomerate showing the composition with bigger sized pebbles.

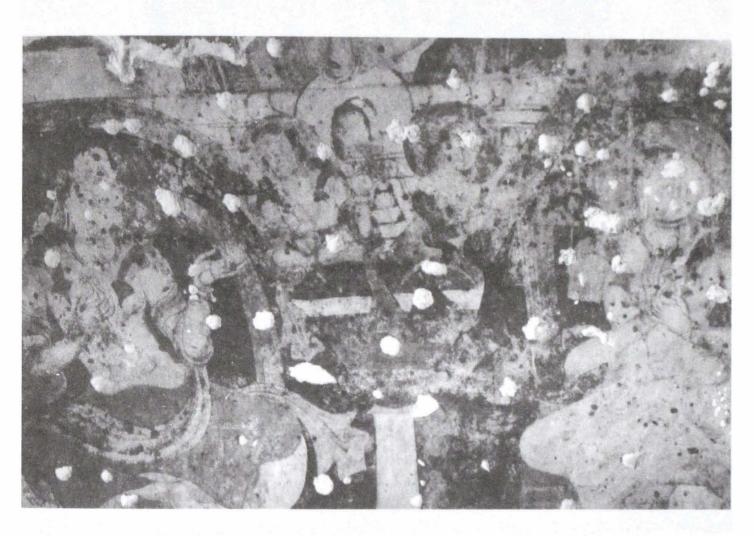
The painted surface in the main niches and caves in the Wall of the Buddhas is in the grip of rapid decay. The pigment has become loose and has flaked away from over large areas. The plaster itself has become very weak and has come off the rock surface at various places. In addition the binding medium used in the colours has lost its cementing property. Deleterious accretions of sooty and tarry deposits, dust and dirt, cob-webs, insect nests etc. Have played havoc with the paintings which are in a highly deteriorated condition.

25. Paintings on the ceiling of the niche of the Big Buddha.

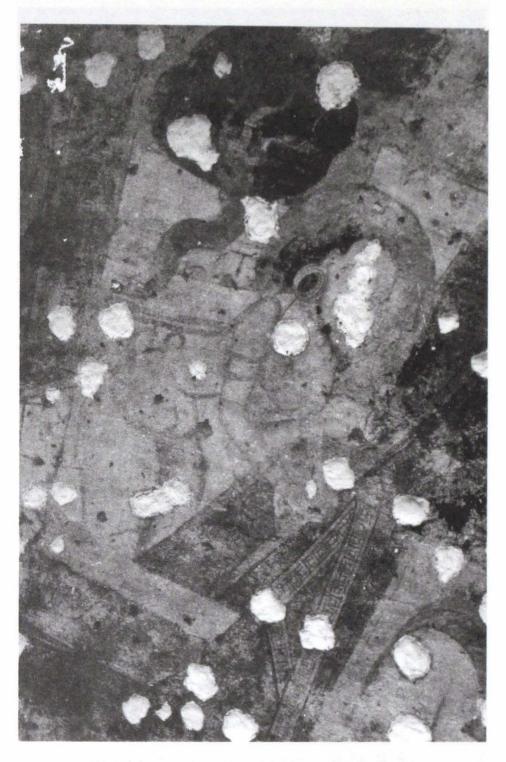
27. Painting on the ceiling of the niche of the Big Buddha.

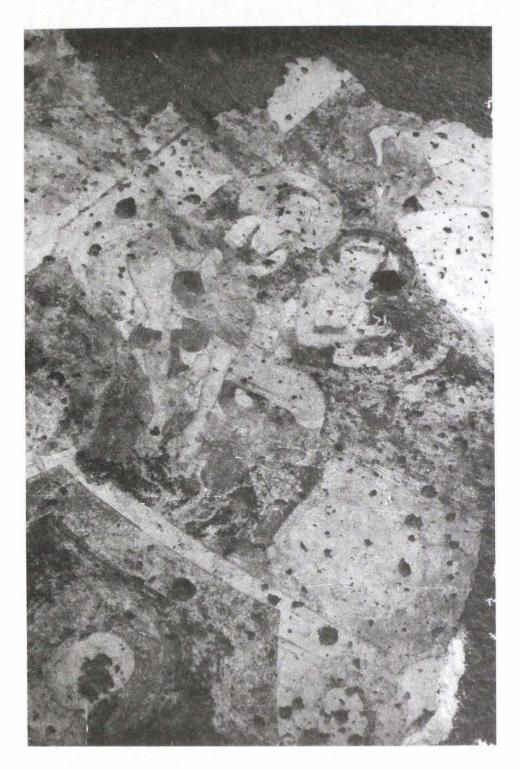
28. Paintings on the ceiling of the niche of the Big Buddha.

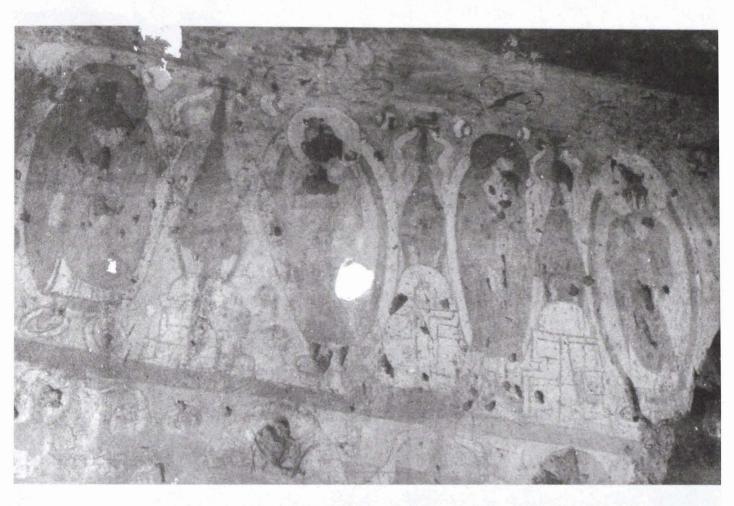
29. Painting on back wall of the verandah of cave 12 to the right of the Small Buddha.
